# Field and laboratory investigation into scour around breakwaters

Fausset, S.

Fausset, S. (2017) 'Field and laboratory investigation into scour around breakwaters', The Plymouth Student Scientist, 10(1), p. 195-238.

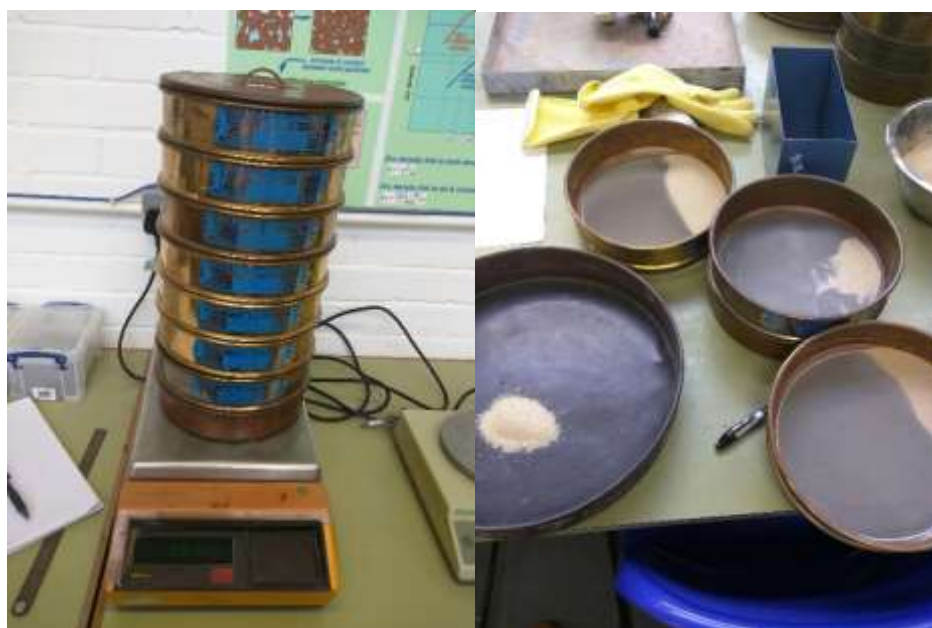
**Figure 2:** a) Sieve test apparatus b) Individual sieves showing collected bed material post-test.

In preparation for the preliminary experiments a sample of the sediment in the tank was taken, dried in an oven over night and sieved to examine the size of the sediment. The sediment in the tank was constant throughout the tank but the sample

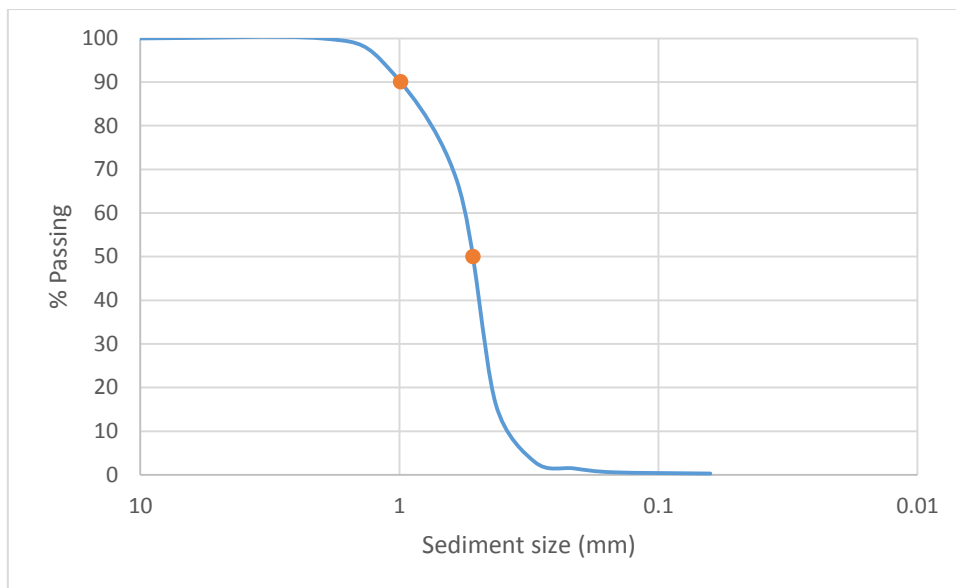
**Figure 3:** Percentage passing vs sediment size for bed material

The sieving of the sand concluded that the bed material was fine uniform sand based on the percentage passing for D50 and D90. D50 was found to be equal to 0.52mm and D90 was found to be equal to 0.99mm, this is shown in Figure 3. This sand was used as sediment in the tank to represent the sea bed material.

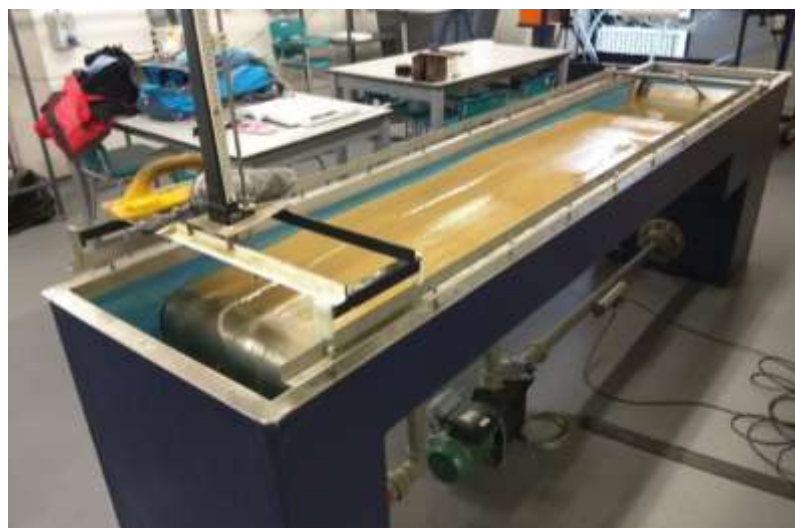
**Figure 6:** Alborn Rig

The Alborn rig shown in Figure 6 has a BomBa PSH Mini 80M 220-230 Volt pump that pumps fresh water through a 48.3mm diameter plastic pipe. An adjustable weir located at the downstream end of the flume acts as a sand trap as well as being used to control the water depth upstream. The level of the sand in the tank was measured using a point gauge and was levelled out to the same level for every test undertaken.

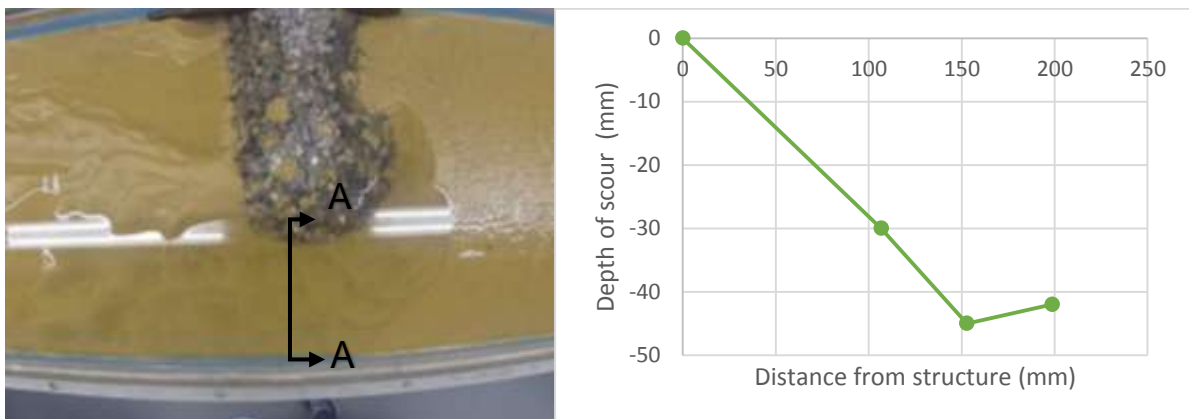
**Figure 9:** a) Falmouth model plan view of scour post-testing of 50mm water depth with a flow of 3.7 l/s b) transect A-A profile

Figure 9a shows the scour hole around the structure post-test and highlights the line of the scour hole which is represented in Figure 9b.

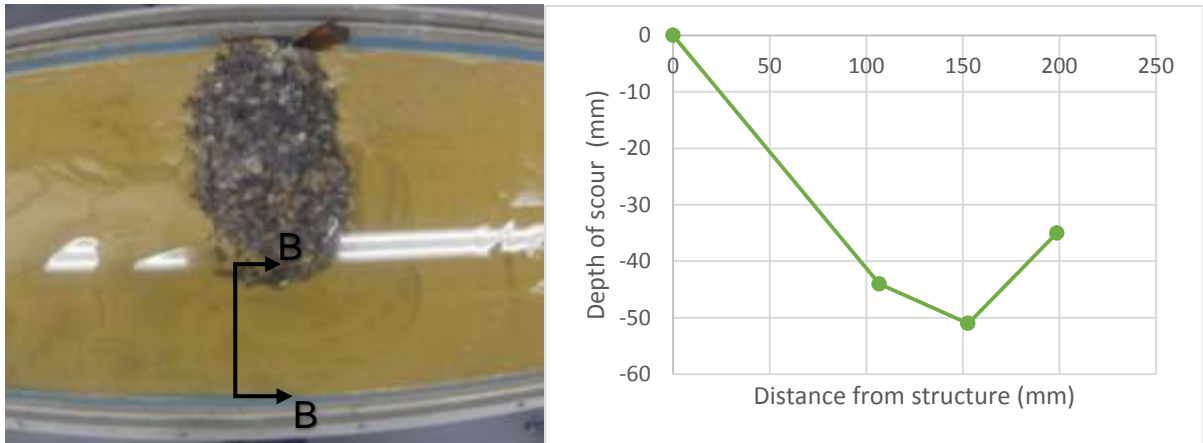
**Figure 10:** a) Mount Batten model plan view of scour post-testing of 40mm water depth with a flow of 3.7l/s b) transect B-B

Figure 10a shows the scour hole around the structure post-test and highlights the line of the scour hole which is represented in Figure 10b.

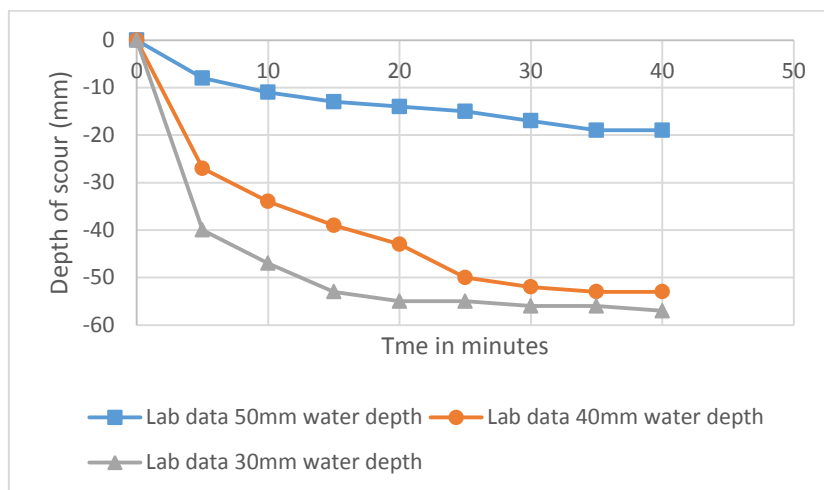
**Figure 11:** Preliminary scour depth vs time

Figure 11 shows the time taken for equilibrium to be reached during testing of three different water depths; 50mm, 40mm and 30mm. The depths represented in this graph are the maximum depths achieved and show that with a shallower water depth of 30mm the greatest depth of 57mm was obtained, whereas a maximum depth of 18mm was reached with a water depth of 50mm. This indicates a higher local velocity of flow past the structure with the shallower water depth. Both the 40mm and 30mm water depths follow the same trend and indicate that with this increased flow a greater scour representation is achievable. 30mm is the smallest water depth investigated in this experiment due to scaling effects discussed previously. 50mm water depth was the largest depth achievable while a sediment depth of 60mm was maintained across all tests.

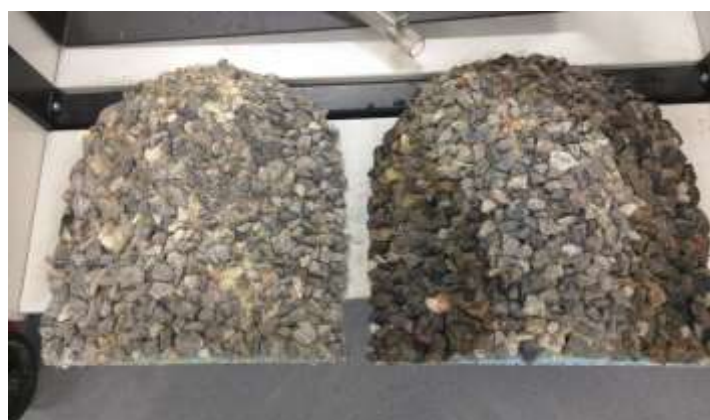
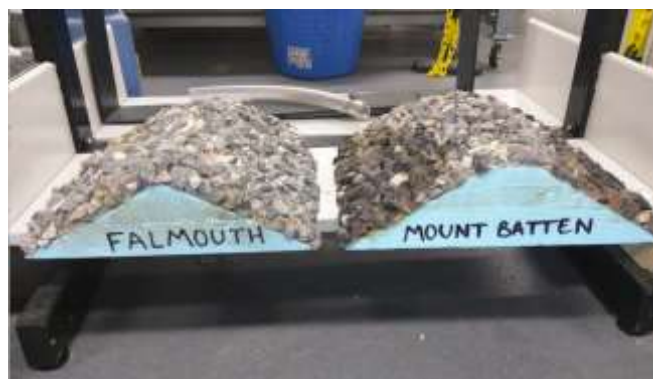
**Figure 12:** a) Plan view of Falmouth and Mount Batten models (L-R) b) Elevation view of Falmouth and Mount Batten models (L-R)

Both the Falmouth and Mount Batten breakwater models made for this project were comprised of a dense foam core that geometrically represents the core layers of the breakwaters. Two layers of aggregate covered the foam core, one layer of 20mm and one layer of 10mm. The aggregate layers are attached to the foam cores using a silicone sealant which allows flow of water around the individual stones but provides a strong hold and prevents the stones being removed during testing.

Froude scaling and symmetrical scaling were used to produce a model of the Mount Batten breakwater at a 1:80 scale and a model of the Falmouth breakwater at a 1:100 scale shown in Figure 12a and 12b.

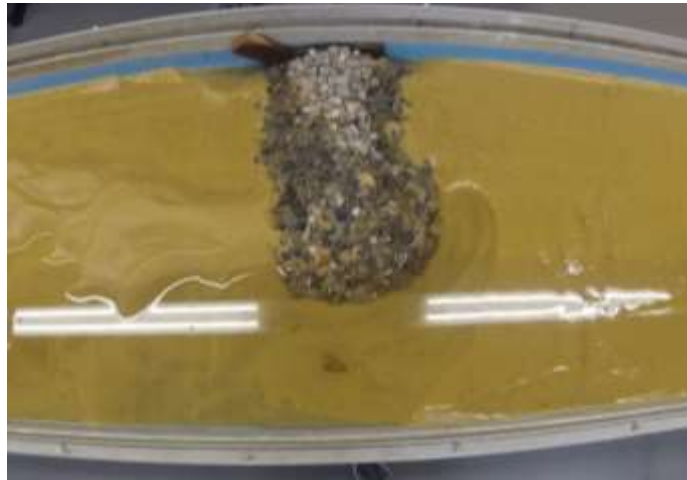
**Figure 13:** Image of Falmouth model post-test indicating smooth upstream bed material

The structures were placed in the flume at 102 cm which is half way along the length of the flume. This was to ensure that any turbulence experienced from the pumps did not affect the scouring process of the experiment. As shown in Figure 13 the

upstream half of the flume depicts smooth unsettled sediment which indicates little to no interference from the pumps. This was to ensure clearwater scour was observed.

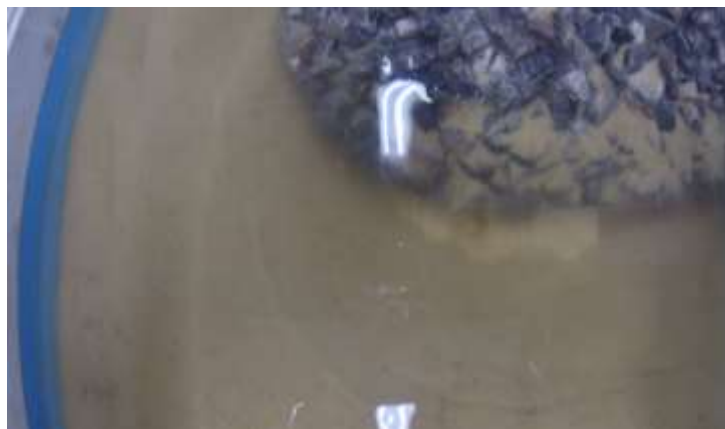
**Figure 14:** Falmouth model fail

Figure 14 shows the model has been lifted and exposed the wooden base underneath. The model itself weighs 6.58Kg and was subject to 40mm of water at a flow rate of 3.7l/s, the behaviour of the model was unexpected when considering the weight of the model compared to the water depth, however this problem was remedied by placing paving bricks on top of the model to weigh it down. This was an acceptable solution to the problem as in this case the point of interest is the scouring occurring around the structure and not the structure behaviour itself. The results from this particular test were omitted and the test was repeated.

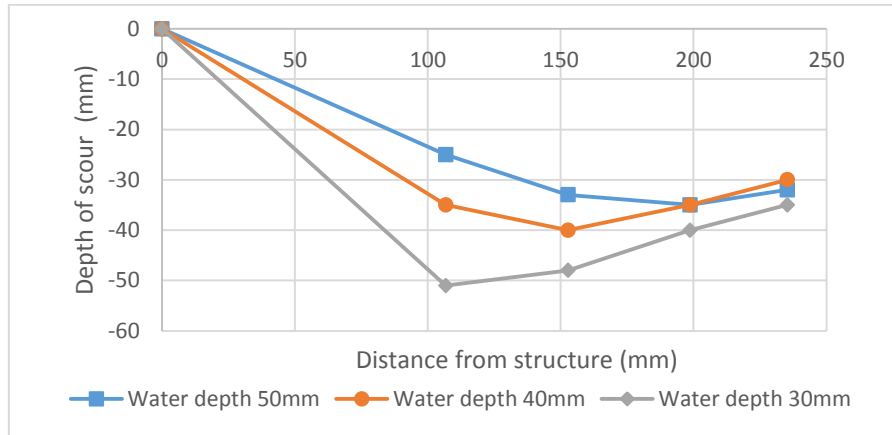
**Figure 15:** Graphical representation of scour depths from the end of the Falmouth model for varying water depths.

The end of the structure is located at 0mm, all measurements are taken from the end of the structure. The maximum depth of scour that was recorded i achieved when a water depth of 30mm was used whereas the smallest scour depths achieved are that of the 50mm water depth, this implies that with a smaller water depth the scour depths occurring will be deeper, this is consistent with the idea that the lower the water depth the faster the water flow past the structure will be. This is due to the pump in the Alborn rig pumping at a continuous flow rate of 3.7l/s.

A graphical representation of the maximum recorded scour depths in a cross sectional tangent of the scoured area at the end of the structure is shown below in Figure 15.

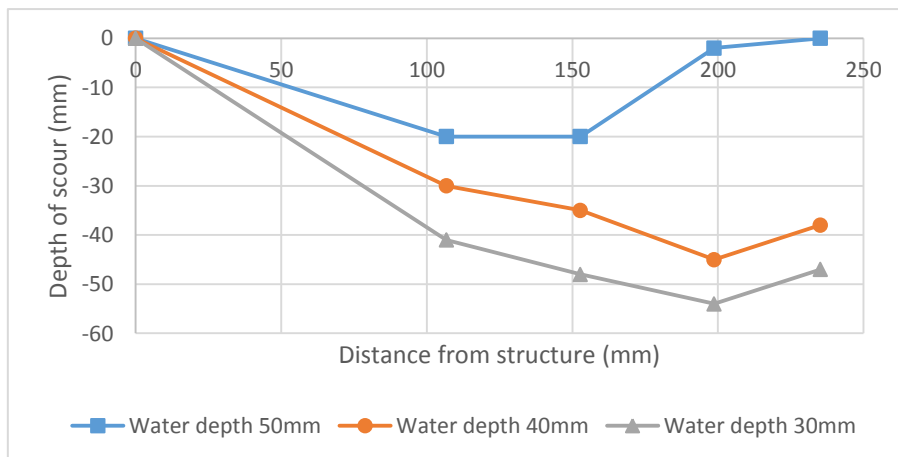
**Figure 16:** Graphical representation of scour depths from the end of the Mount Batten model for varying water depths.

Similar to the results of the Falmouth model the maximum scour depth achieved was with a water depth of 30mm and the least scour was achieved with a water depth of 50mm implying an increase in scouring effect in shallower water.

A graphical representation of the maximum recorded scour depths in a cross sectional tangent of the scoured area at the end of the structure is shown below in Figure 16.

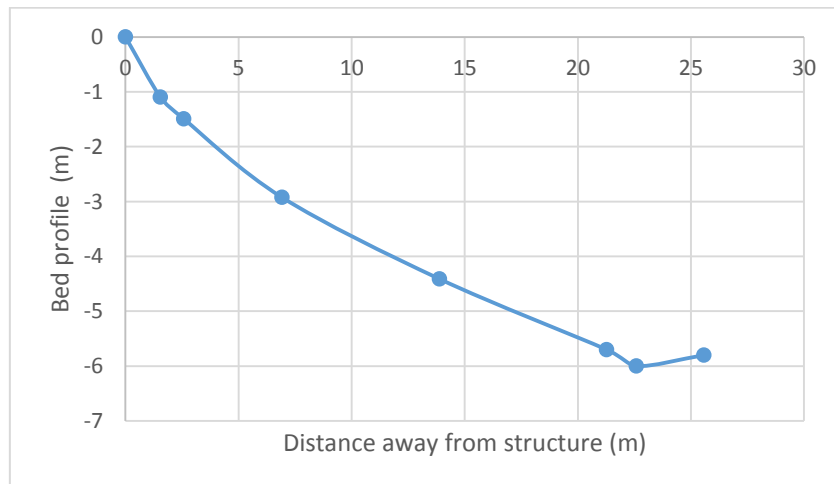
**Figure 18:** Graphical representation of the seabed profile at the end of the Mount Batten breakwater

Figure 18 shows the drop in seabed level at the end of the breakwater where 0 depths represent 4.1m below the waterline.

Following the bathymetric survey undertaken for this project in January 2016 data about the seabed depth around the structure was collected and a depth profile of seabed at the western end of the breakwater was produced with depths measured from 0 as chart datum.

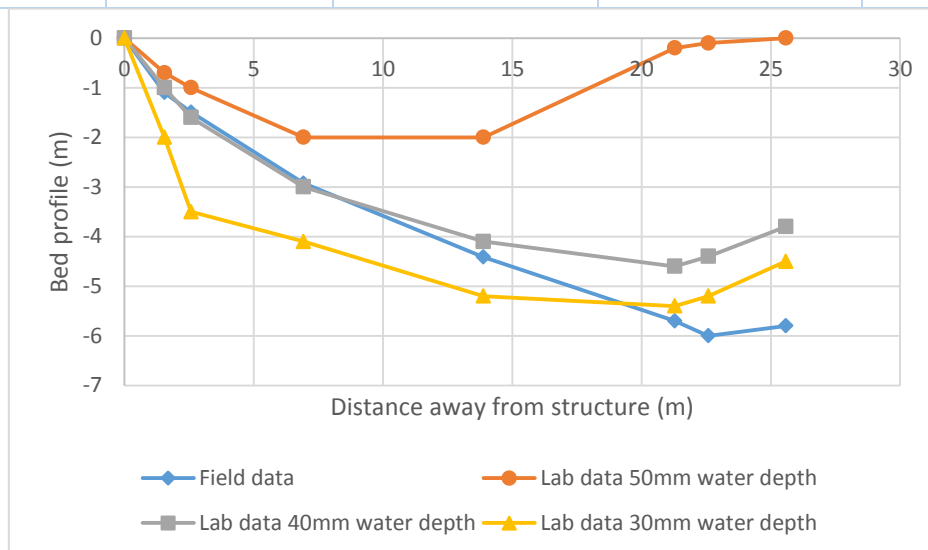
**Figure 20:** Mount Batten field and lab data comparison

Figure 20 shows a close similarity to the field data with a comparable trend between the results of water depth of 40mm and the field data. The 30mm water depth plot follows the trend but cannot be called a close representation and the 50mm water depth plot does not accurately represent the field sea bed profile, suggesting that a

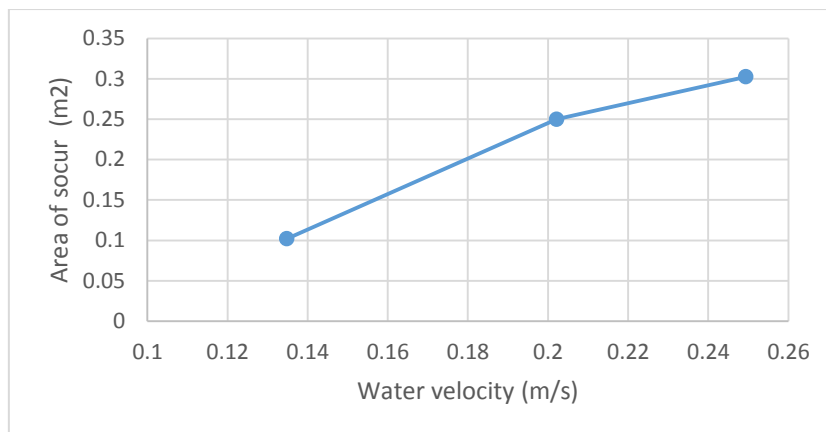
**Figure 22:** Mount Batten area of scour vs water velocity

It is clear that there is a relationship between the depth of the scour area and the increase in water velocity. This is to be expected since increased turbulence usually follows increased velocity (Hamill, 2011).

The maximum areas of the scour holes were measured after 40 minutes and are displayed in Figure 22.

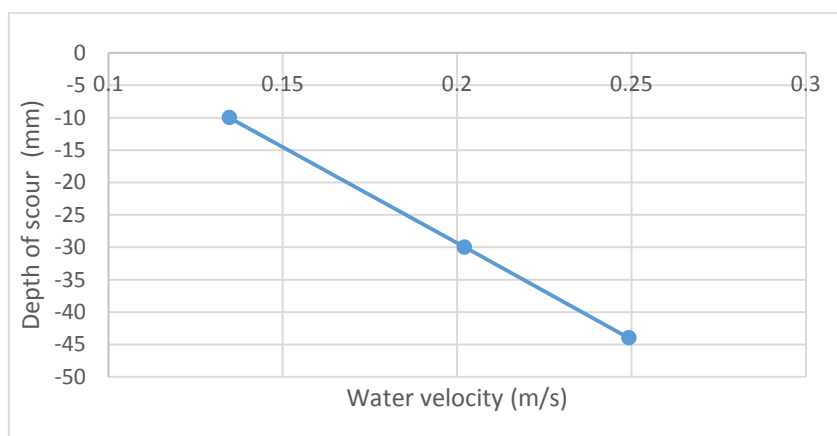
**Figure 23:** Mount Batten scour depth vs water velocity

As can be seen from the graph above there is a directly proportional relationship between scour depth and the velocity of the flow. The maximum scour depths recorded increase as the velocity of the flow increases meaning the deepest scour occurs as water velocity increases to 0.25 m/s.

Figure 23 presents the data collected about the relationship between depths of scour and water velocity.
