# Investigation into the process of cured-in-place pipe sewer rehabilitation

Caitlin Mitchell

*Project Advisor: [Tony Tapp](#), School of Engineering, Computing and Mathematics, University of Plymouth, Drake Circus, Plymouth, PL4 8AA*

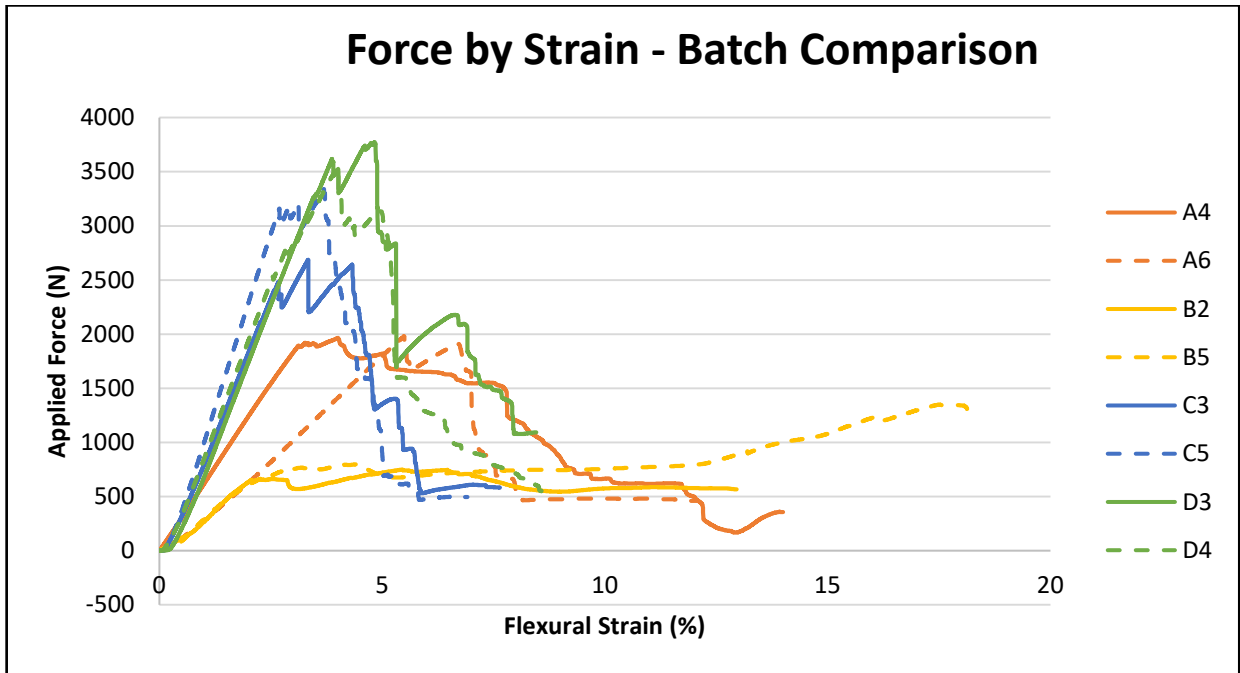
Figure 7 is showing the same style of batch comparison but comparing the applied force with the flexural strain (%). Full batch graphs can be found in appendix 4.

Figure 7: Force by strain - batch comparison
