# Remote sensing of boat abandonment using Google Earth

4 **Millicent R. Payne and Andrew Turner\***

15 **Abstract**

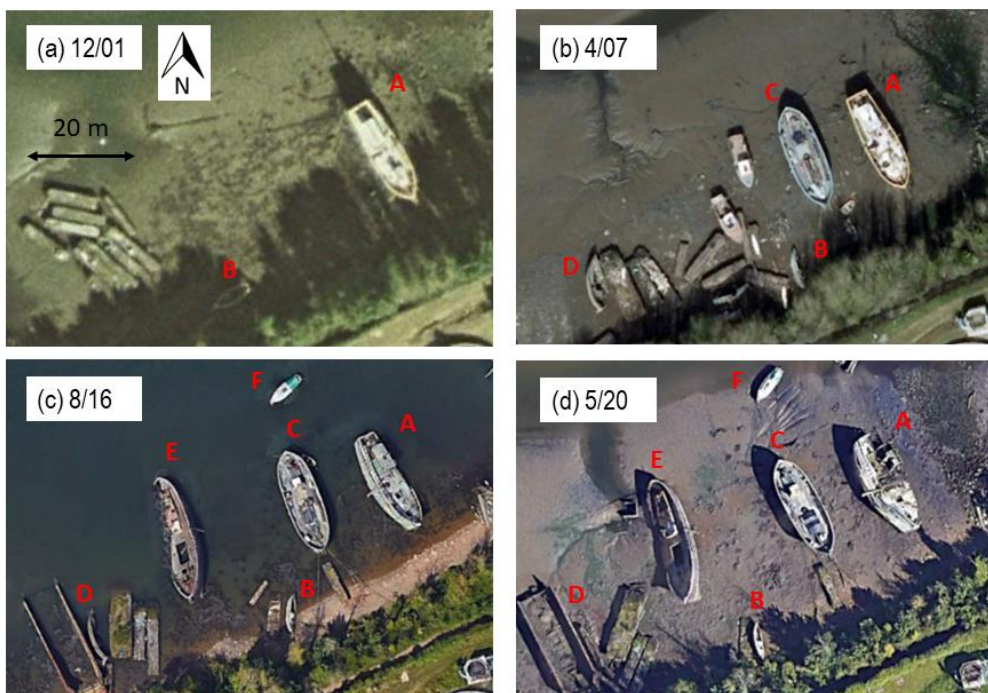
140 Figure 2: GE imagery of a region of Hooe Lake, Plymouth (50°21'22"N, 4°06'28"W), where boat  
141 abandonment has been increasing over the past twenty years. Selected dates are shown as  
142 month/year and boats labelled in each image are described in the text.

86 objects or details that could be observed and including distinctive boat parts whose precise  
87 dimensions were established from a site visit to Hooe Lake (Figure 2), ranged from about 0.3 to 2 m.  
88 Because of constraints on positional accuracy resulting from the use of images from different  
89 satellites that are not orthorectified, coordinates are reported with a suitable precision (and to the  
90 nearest whole second). Where available, imagery from Google Street View, an additional feature of  
91 GE that provides interactive panoramas from positions along public streets, was inspected to gain  
92 further details about specific boats.

105 In many cases, identification of abandoned boats was straightforward in that a vessel would remain  
106 at a specific location and undergo decay. Boats could first appear on imagery at a particular date or  
107 be present throughout the whole time series recorded. In other cases, identification and  
108 characterisation was more complex. This is exemplified by the GE imagery of the intertidal zone of  
109 Hooe Lake, Plymouth, captured on four selected dates that illustrate the evolution in the number  
110 and condition of several boats (Figure 2). Thus, boats A and B, of 20.4 m and 9.8 m in length,  
111 respectively, are evident on the earliest imagery (December 2002). Boat A remains in the same  
112 position throughout the time series to May 2020, but has begun to list by August 2016 and exhibits  
113 considerable damage, including by fire, in the most recent image. In contrast, boat B has shifted its

114 precise location, either because of tidal currents or intervention during the mooring or  
115 abandonment of other boats and structures, but is nevertheless classed as abandoned. Boats C and  
116 D, of lengths of 20.7 m and 17.8 m, respectively, appear in imagery dated April 2007, and while the  
117 latter is clearly abandoned and decaying, the former remains moored and appears to have  
118 undergone recent modification. A subsequent visit to the location revealed that the boat is

119 undergoing restoration on an intermittent basis and is, not, therefore, classified as abandoned.  
120 Boats E (32.0 m) and F (8.0 m) appeared between 2007 and 2010 and in 2016, respectively, and  
121 while the former is in poor condition and taking in water, the latter appears to be securely moored  
122 and in relatively good condition. Since boat F had been at the same location for only four years, the  
123 principal criterion for abandonment was not, therefore, met.

197 Scattered clustering occurs when there is a growth of abandoned boats at a particular locality that  
198 are not moored together. This type of clustering is evident in Hooe Lake, Plymouth (Figure 2), and at  
199 Lytchett Bay in Poole Harbour (Figure 5) and has been reported in studies of the east coast of  
200 England (Turner and Rees, 2016) and the Pacific and Caribbean territories of the US (Lord-Boring, et  
201 al., 2004). Such locations are perceived to be convenient and acceptable because they evade any  
202 punishment or other repercussions; consequently, they attract successive abandonments by the

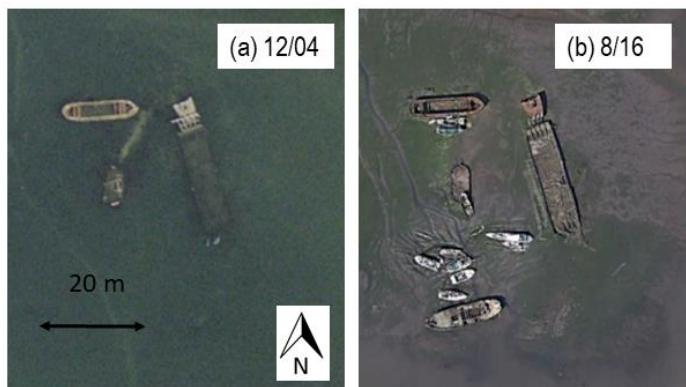
221 Figure 4: GE imagery showing the evolution of a cluster of abandoned boats on the Itchen Estuary  
222 ( $50^{\circ}54'57''\text{N}$ ,  $1^{\circ}22'55''\text{W}$ ) between (a) 2004 and (b) 2016.

189 Many of the boats on intertidal flats were also encountered in distinct clusters of up to twelve boats  
190 (with clusters defined as at least two boats within 100 m of each other). The majority of clusters  
191 were observed in the sheltered intertidal flats of estuaries and embayments around Portsmouth,  
192 Southampton, Poole and Plymouth (Figure 1). In some cases, clusters appeared to develop over a  
193 period of time through mooring aggregation, and as exemplified in Figure 4. Here, boats abandoned  
194 before 1999 in the Itchen Estuary (and illustrated in 2004) were subsequently used for the mooring  
195 and abandonment of newer vessels, resulting in the development of a dense cluster (and illustrated  
196 in 2016).

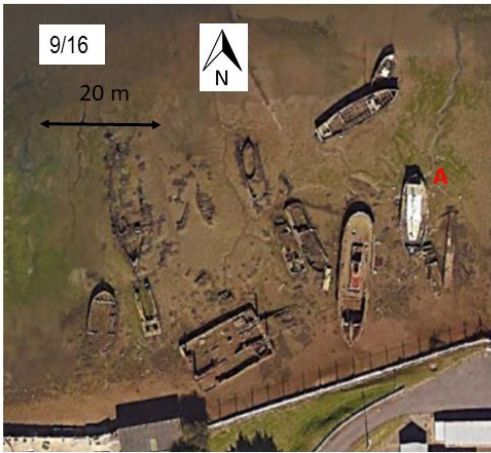
Figure 6: GE image of a cluster of abandoned boats in Forton Lake, Portsmouth Harbour (50°48'11"N, 1°07'57"W). Most boats, including those partly submerged in the sediment, were abandoned following the closure of a boatyard in 1959, but boat A appeared in 2015.

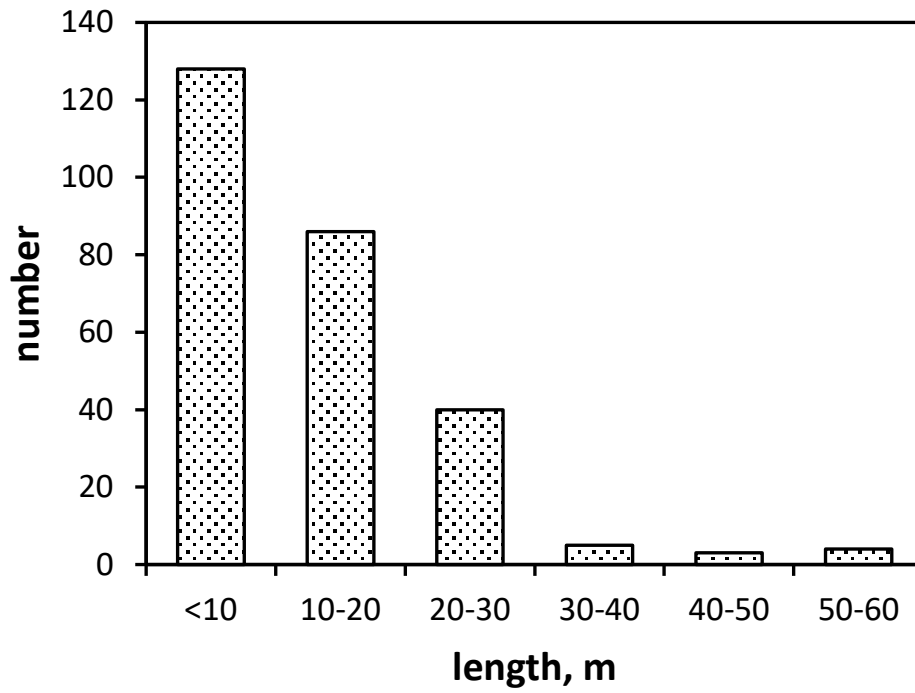
276 Figure 7: Size distribution of the abandoned boats identified along the south coast of England.

The size distribution of the abandoned boats identified in the present study is shown in Figure 7. Length ranged from 2.6 m to 60 m, with mean and median values of 13.4 m and 10.5 m, respectively, and frequency exhibited a reduction with increasing length. Regarding boat condition, and according to our criteria, 190 were broken down, 43 were damaged, 31 were partly submerged and two were intact. Amongst the abandoned boats, 95 could be defined in terms of their material of construction. Thus, based on colour, texture, panelling and decay, and, where available, imagery generated by Google Street View, 90 were identified as being of timber construction and five were identified as being of steel construction.

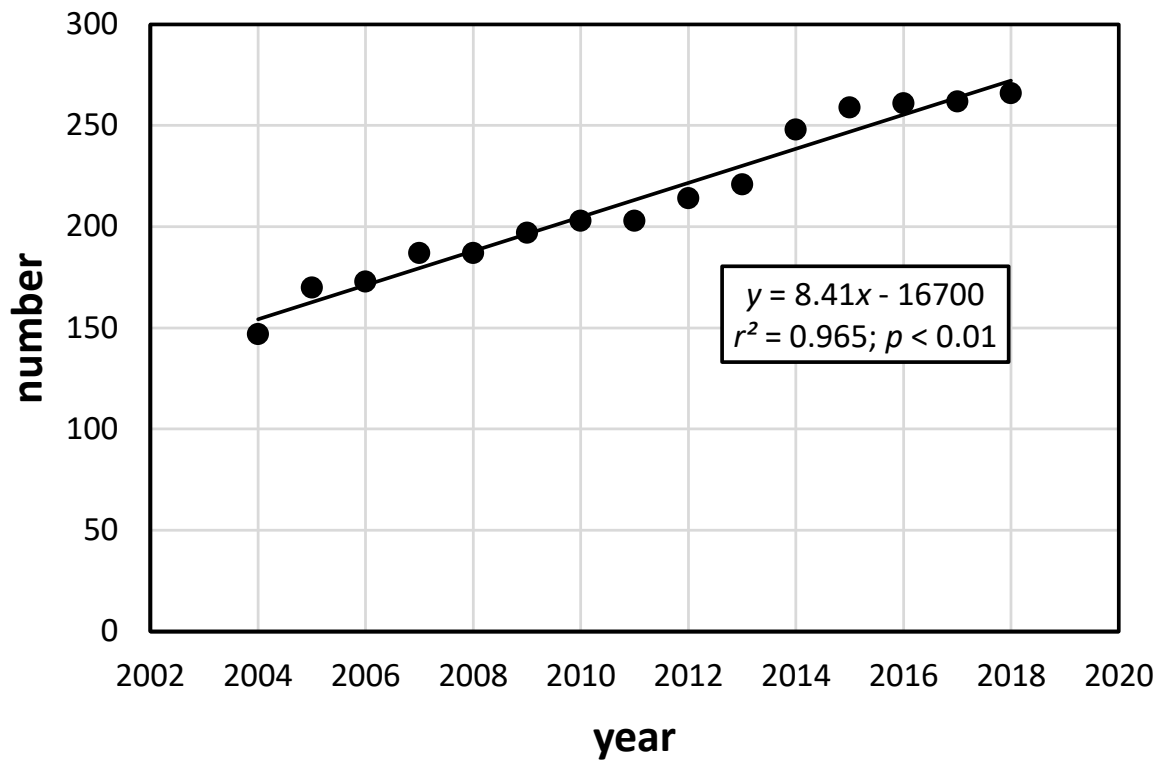
280 Figure 8: Cumulative frequency distribution of date of boat abandonment along the south coast of  
281 England. The regression (solid line) is defined by the parameters annotated.

Local databases and historical accounts of shipwrecks and other underwater structures mention a few of the larger foreshore boats identified in the present study with abandonment dating back to 1945 (Langley and Small, 1988; The SHIPS Project, 2021). However, and despite GE imagery available since 1999 in some areas, the earliest date of recording across the entire coastal region surveyed was 2004. The year of abandonment since this date is shown in terms of cumulative frequency in Figure 8 and reveals a steady increase in the number of boats that averages 8.4 per year and a

269 relationship between cumulative frequency and year of abandonment that is defined by linear  
270 regression with statistical significance. Note that this figure is not offset by boat recovery as none of  
271 the abandoned vessels identified were removed from their locations during the time period  
272 surveyed.
