Wolf Rock Lighthouse Long-Term Monitoring

James Brownjohn ^{1,*}, Alison Raby ² , James Bassitt ¹, Alessandro Antonini ³ , Zuo Zhu ¹ and Peter Dobson ⁴

Abstract: Wolf Rock Lighthouse is a Victorian era masonry structure located in an extreme environment facing the fiercest Atlantic storms off the southwest coast of England whose dynamic behaviour has been studied since 2016. Initially, a modal test was used to determine modal parameters; then, in 2017, a monitoring system was installed that has operated intermittently providing response data for a number of characteristic loading events. These events have included wave loads due to storms, a small UK earthquake, helicopters landing on the helideck, and the grounding of a ship on the reef. This is believed to be the most extensive experimental campaign on any structure of this type. This paper briefly describes a unique project involving the characterisation and measurement of dynamic behaviour due to different forms of dynamic loading.

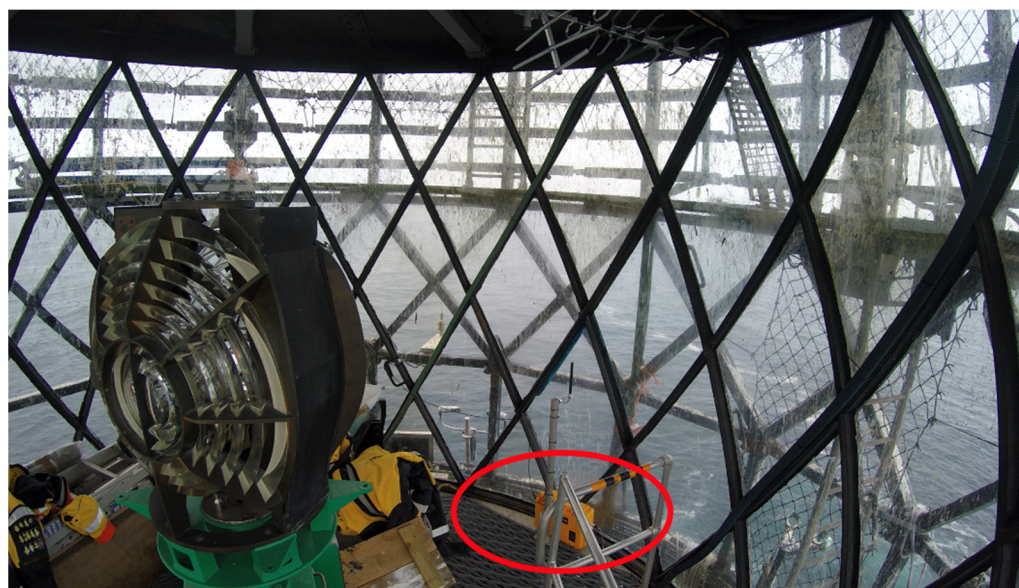
Figure 9. Yellow logger (data acquisition, storage, and communication) box in lantern room. Steel framework of helideck is visible outside.

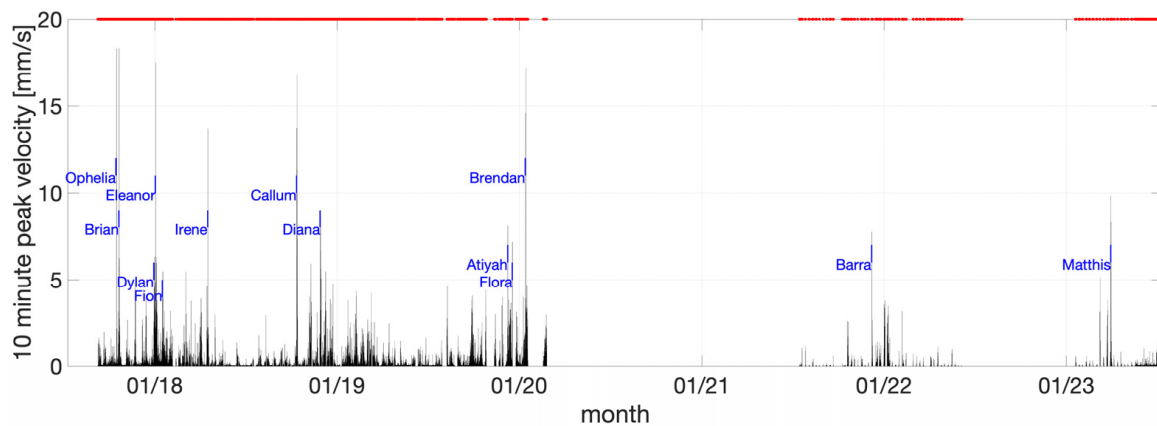
Figure 12 shows peak 10 min velocities over five storm seasons (much of 2020/21 was missed due to COVID-19). Rather than taking accelerations for the strongest wave impacts, peak velocities obtained from the vector sum of integrated level 7 accelerations are shown as they directly indicate wave loads. This is due to the impulsive nature of the response (evident in Figure 10) via the relationship of known modal mass and change of velocity (the indicated peak values) to wave force \times duration.

Figure 12. Recorded battery room peak velocities. Red dots indicate available data.

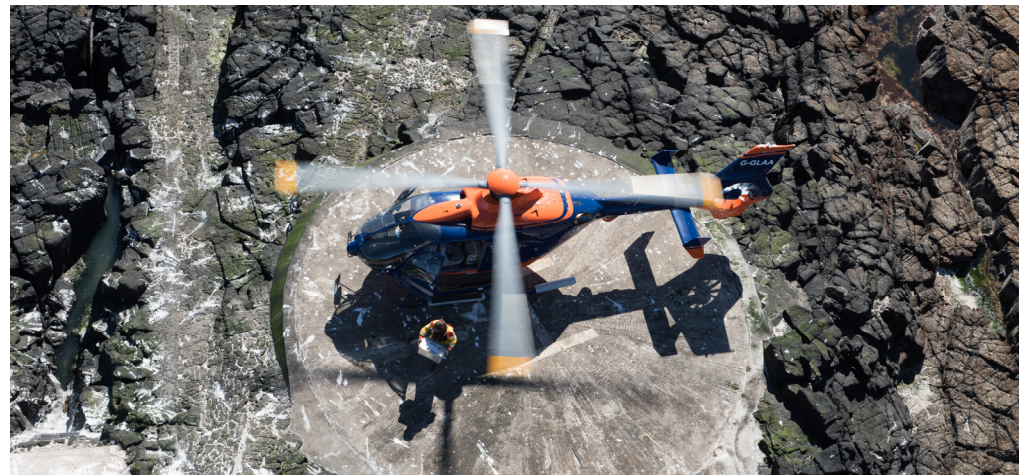
Figure 14. EC135 helicopter G-GLAA on Dubh Artach lighthouse helipad.

While (for safety reasons) it has not been possible to record helideck accelerations directly during helicopter landing, unloading, loading, and takeoff, it has been possible to record the tower response on numerous occasions via the monitoring system or the accelerometer array used for ambient vibration survey. The aircraft currently used is an Airbus EC135 with a four-bladed rotor (Figure 14) with 100% rotor speed achieving approximately 400 revolutions per minute (RPM).

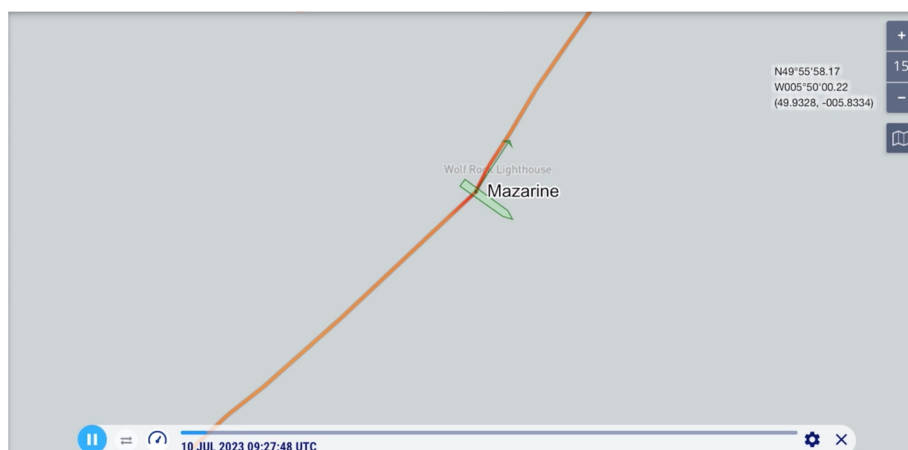
On 10 July 2023, the RoRo cargo ship Mazarine, enroute from Ireland to Belgium, lost power and drifted onto the reef of Wolf Rock. Marine tracking shows that the grounding occurred at 09:27 UTC (10:27 local time). The tide was still rising at the time (high tide at 10:00 UTC) and the ship rotated around the stern, resuming a drift towards the Cornish coast at 09:50 (Figure 18).

Figure 18. Trajectory of Mazarine, indicating grounding at 09:27.
